Combined use of non-destructive methods for the assessment of facade anomalies of heritage buildings with structural concrete elements

Laboratório Nacional de Engenharia Civil (LNEC)

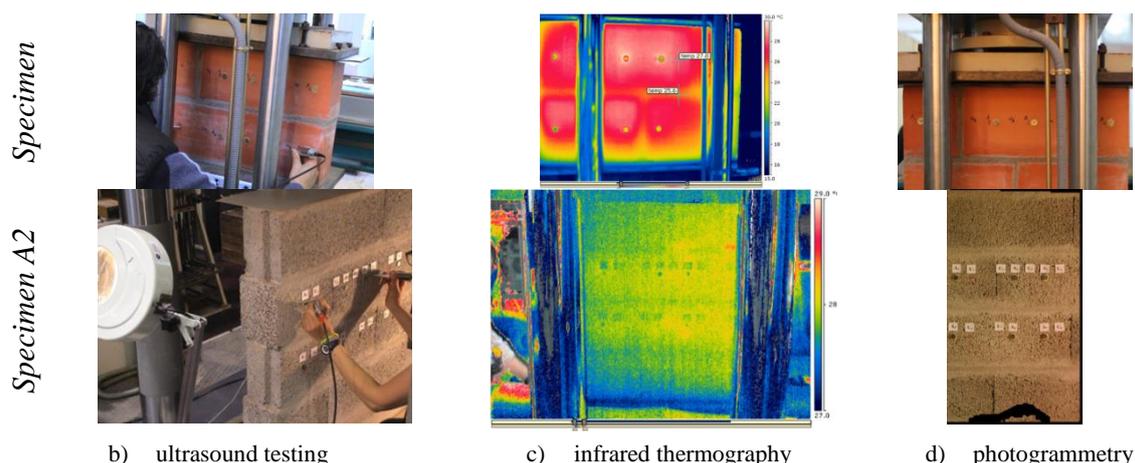
IRT applied to Specimen A1 revealed that the cracks could not be detected during the test. Following the previous heating of the specimen it was only possible to distinguish the different materials; in the Specimen A2, IRT also could not detect the cracks because the cracking occurred in an area outside of range view of infrared thermography equipment (Fig. 6).

Fig. 6 Use of NDT in the compression test of Specimen A1 and Specimen A2

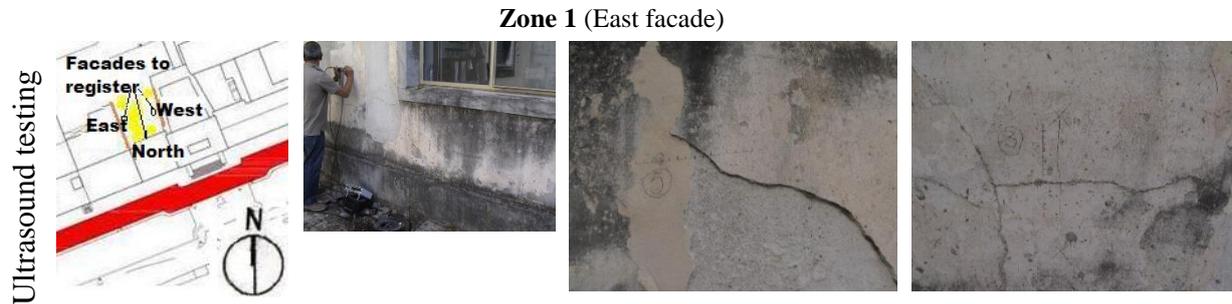
US was used in the analysis of anomalies of the East façade (Fig. 7). The results show that, with the indirect measurement, it was possible the detection of cracking and local detachment of the facade renders.

Fig. 7 Use of ultrasound testing (indirect measurements) for the detection and evaluation of anomalies occurring on East facade

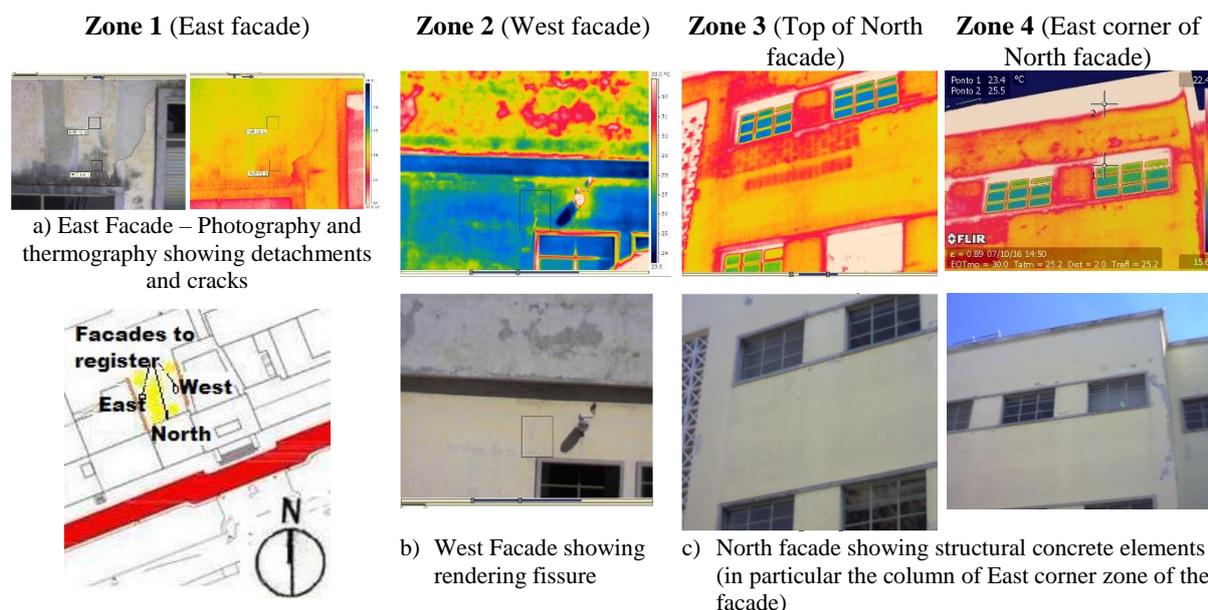
East wall of the building (Fig 8a) was analysed without solar incidence that not help for a good use of IRT. Nevertheless, it was possible to notice cracks and detached area, also visible in real picture. In opposite facade (Fig 8b), with the imposition of a heat flux (solar radiation) IRT easily detects a crack difficult to spot when seen at ground level. Fig 8c shows the last analysed facade (exposed to North), with structural concrete elements visible with IRT. The area under the window on the left side is more noticeable (warmer) probably due to the presence of a heater inside the room. The white area between the windows identifies detachments of coatings. It was possible to show local detachment of concrete in the column of East corner zone of the facade.

Fig. 8 Use of infrared thermography for the detection and evaluation of anomalies

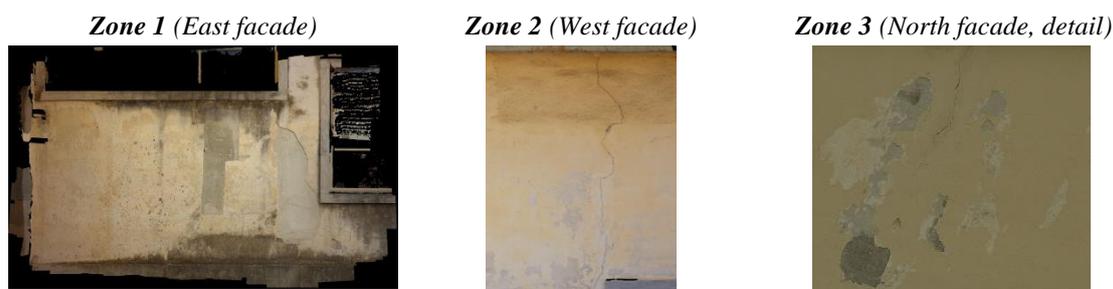
Fig 9 Orthos. Zone 1: most deteriorated area in East facade; Zone 2: a detail of the West facade

Anomalies	Analysis of the NDT used
Zone 1	Cracking and render detachment of the facade masonry wall	Due to easy access of the observer to the inspection local, ultrasounds together with thermography can be useful to analyse the inside state of the façade, namely the respective cracking and render detachment.

Zone 2	Near vertical cracking of the facade masonry wall	Photogrammetry together with thermography can be useful to capture the vertical cracking of the façade
