# The Impact of the 2010 Darfield (Canterbury) Earthquake on the Geodetic Infrastructure in New Zealand <sup>1</sup>

Graeme BLICK, John BEAVAN, Chris CROOK, Nic DONNELLY

**Keywords:** Darfield Earthquake, control, survey, geodetic infrastructure

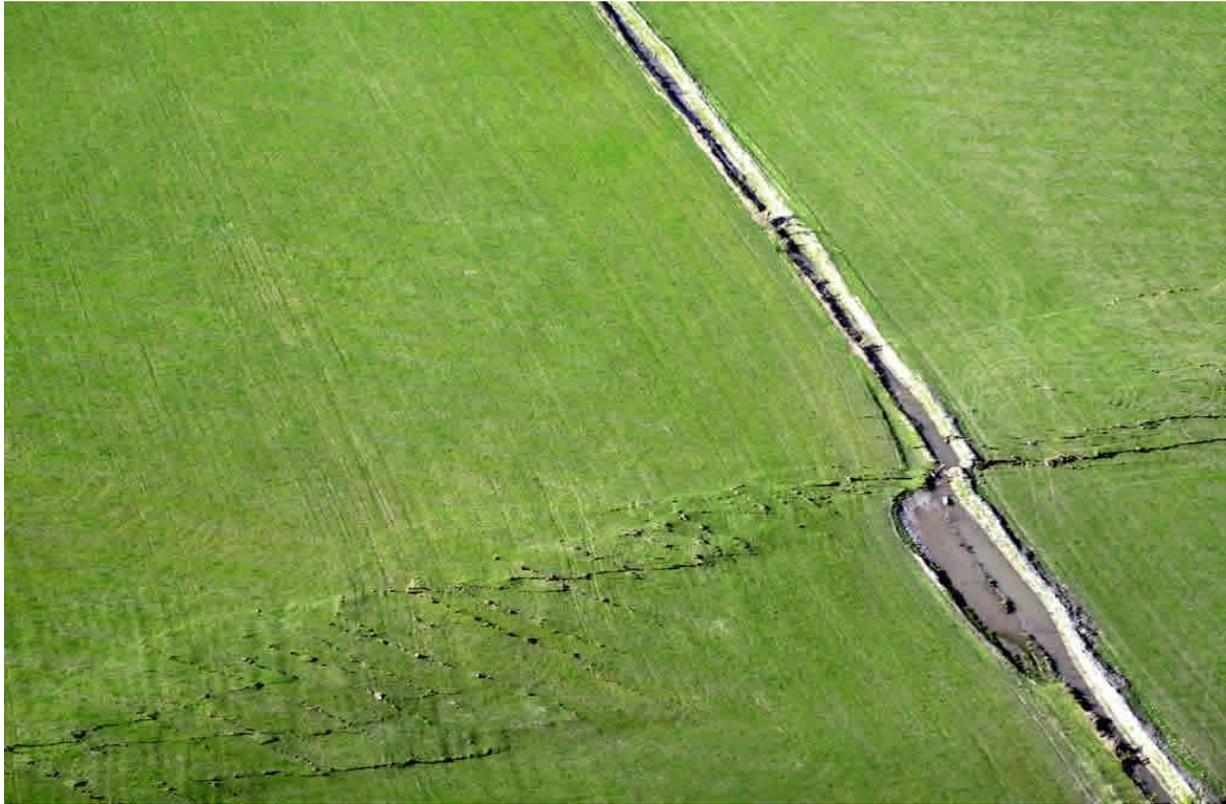
**Figure 2. Trace of the Greendale fault displacing a water canal**

The depth of the earthquake was relatively shallow at about 10km. It caused substantial damage to property and infrastructure, but no loss of life. Across parts of Christchurch, liquefaction caused localised areas of subsidence and lateral spreading. The earthquake occurred in an area that has previously had few earthquakes relative to other parts of the South Island. A fault rupture associated with the earthquake, named the Greendale fault (Figs 1 and 2), occurred along a previously unknown fault and resulted in a surface rupture of several metres.

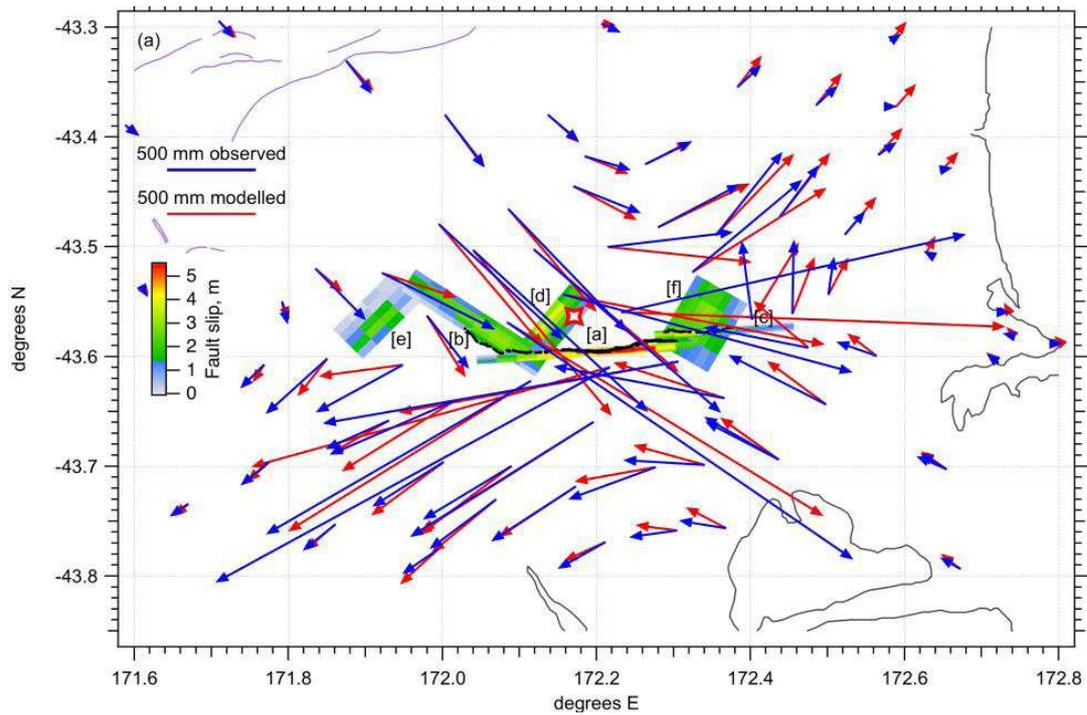
**Figure 3a.** GPS observed (blue) and modelled (red) horizontal displacements. Black line shows the mapped extent of the Greendale fault surface rupture. The coloured image shows the projection to the Earth's surface of the preliminary fault model. The model consists of slip on the Greendale Fault plus three thrust segments on NE-orientated planes. [From Beavan et al 2010]

An immediate post-earthquake survey was undertaken by GNS Science to determine the extent and magnitude of co-seismic displacements. The data were used to determine the initial extents of both horizontal and vertical deformation associated with the earthquake. This and differential InSAR data were used to determine a preliminary source model for the earthquake (Beavan et al 2010). The results showed that the deformation as a result of the earthquake was able to be well modelled by displacement occurring on the strike-slip Greendale Fault and several other fault segments (Fig. 3).

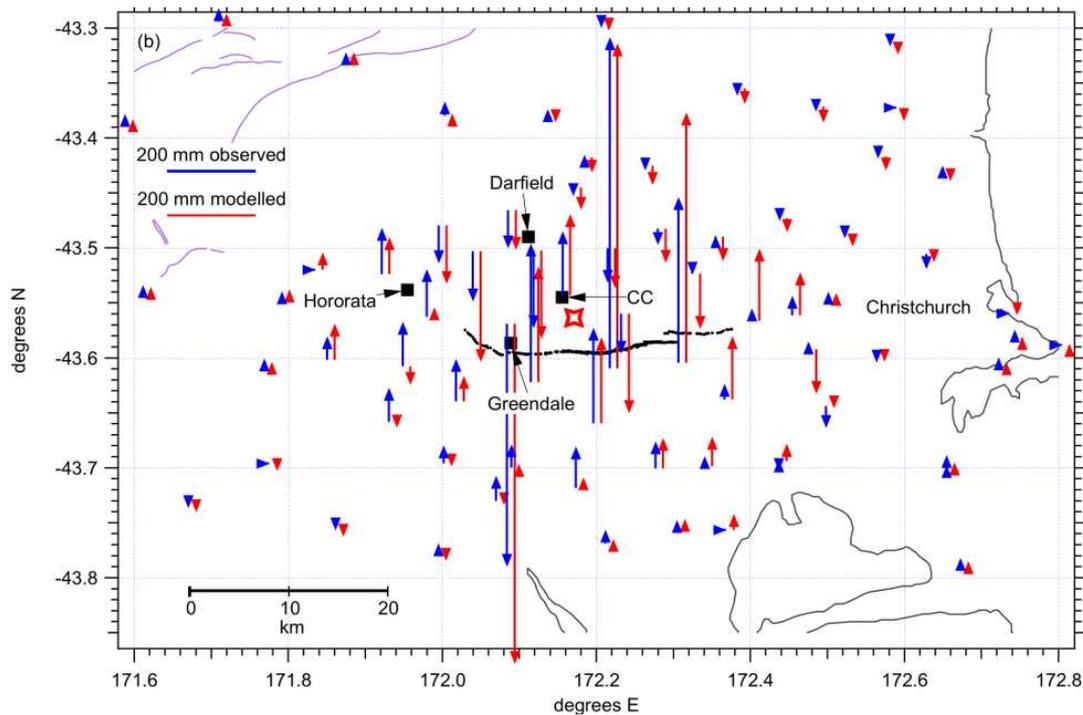
**Figure 3b. GPS observed (blue) and modelled (red) vertical displacements. [From Beavan et al 2010]**

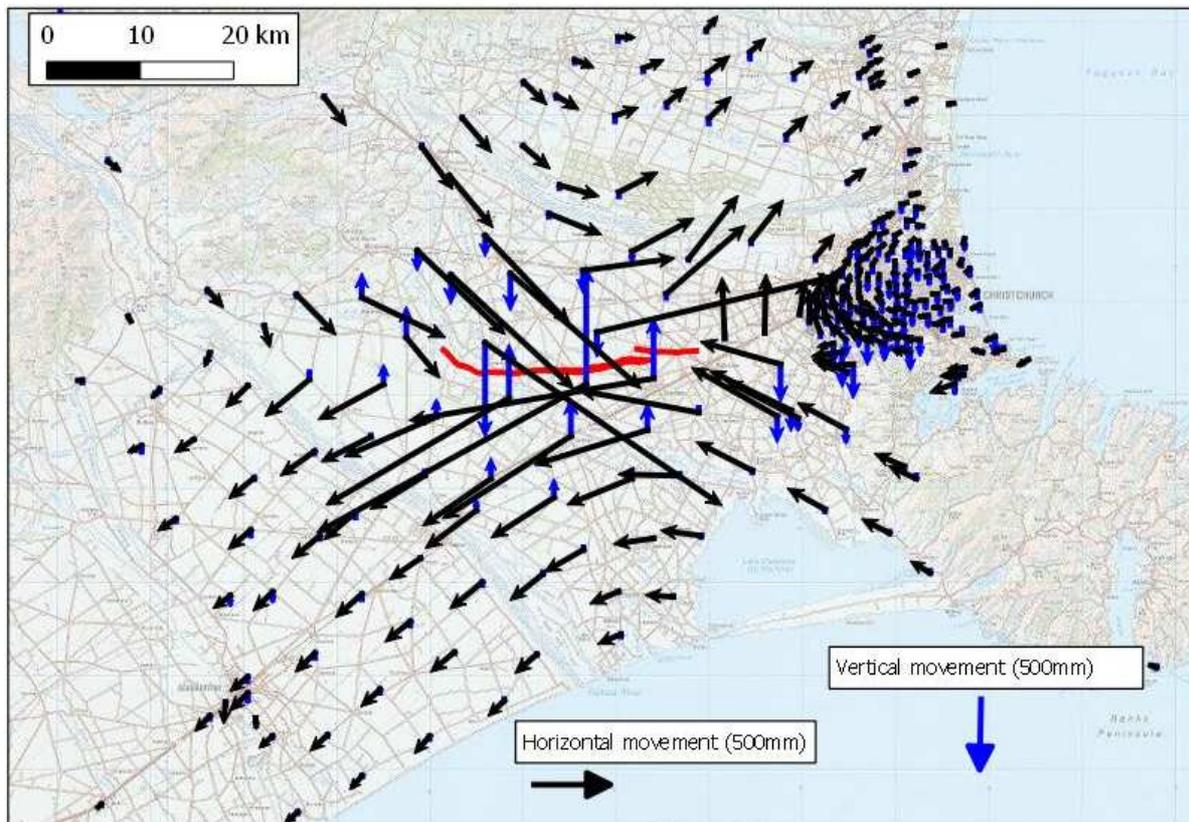
**Figure 4: Horizontal (black vectors) and vertical (blue vectors) displacements in Canterbury resulting from the Darfield earthquake**

Once subsequent surveys confirmed that post-seismic movement was subsiding, work commenced on more extensive surveys by LINZ to resurvey 190 marks which comprise the LINZ existing 1st-4th order networks across the affected area. Control for this survey was provided by the marks surveyed during the earlier deformation survey by GNS Science. Displacements derived from this more extensive survey are shown in Figure 4.

The survey results indicated significant displacements over a wide area. Close to the Greendale fault, horizontal movements of over 2m and vertical movements over a metre were measured. Across Christchurch the movements showed a generally systematic pattern, but some marks showed anomalous movements, both vertically and horizontally. These marks were generally located in areas where localized mark disturbance was suspected to have occurred due to liquefaction.

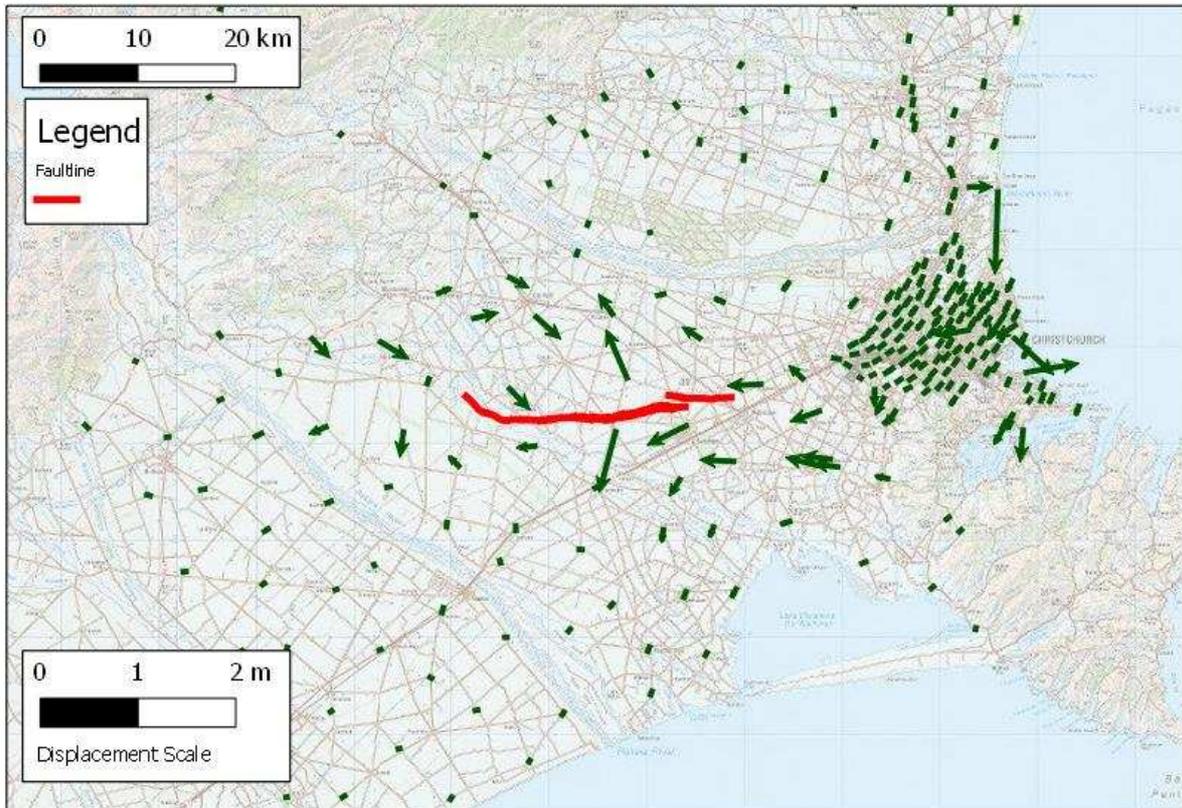
**Figure 5: Residual displacements after observed displacements corrected for displacement model.**

The differences between the observed displacements and those calculated from the early fault model are shown in Figure 5. The model provided a good fit (except close to the Greendale fault and in Christchurch) with residuals of a few centimetres. It is expected that these could be reduced significantly by further refinement of the model, and by empirically adjusting the calculated deformation in areas where there is a clear systematic error in the modelled deformation. The model could also be enhanced with additional survey data, in particular near the fault.

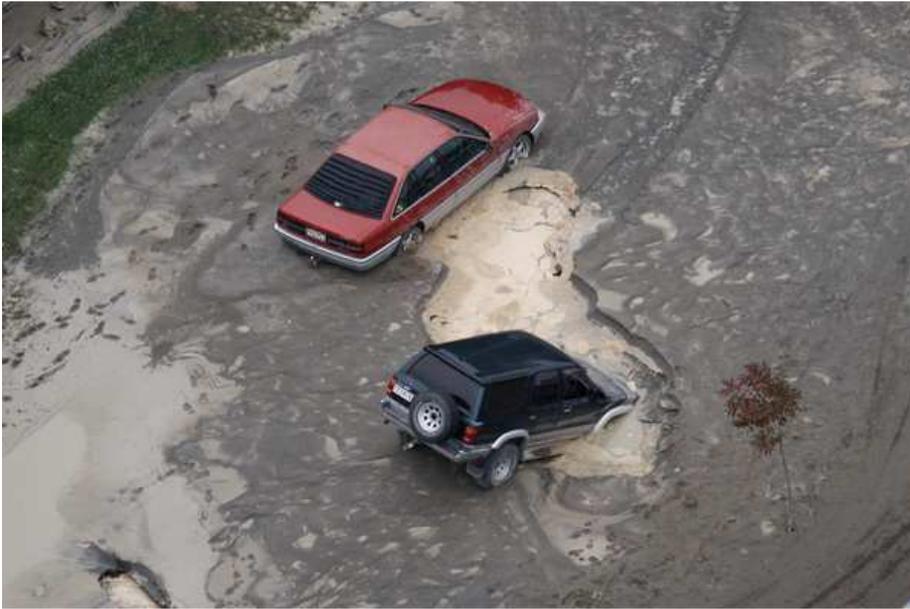
**Figure 6: Area of liquefaction in Christchurch**

The Christchurch earthquake hit on 22 February 2011. Considered to be an aftershock of the Darfield quake, it measured 6.3 on the Richter scale. Although smaller in magnitude than the Darfield earthquake, its location very close to Christchurch resulting in massive property damage and loss of life. Particularly notable were the extensive areas of liquefaction and ground damage (Fig. 6 and 7).

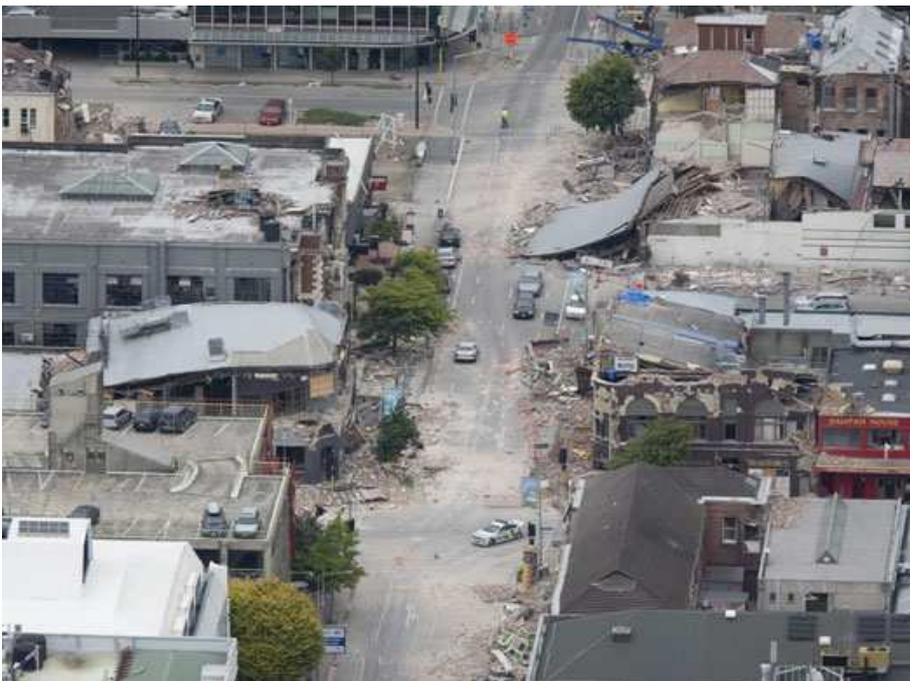
**Figure 7: Damaged buildings in Christchurch**
