*Presented at the FIG Working Week 2017,
May 29 - June 2, 2017 in Helsinki, Finland*

Onshore Drilling Rig Decommissioning at Dibi Area, Benin River A Case Study of Parker-74 Drilling Rig Barge.

Sylvester Efe OWHOJETA, Nigeria

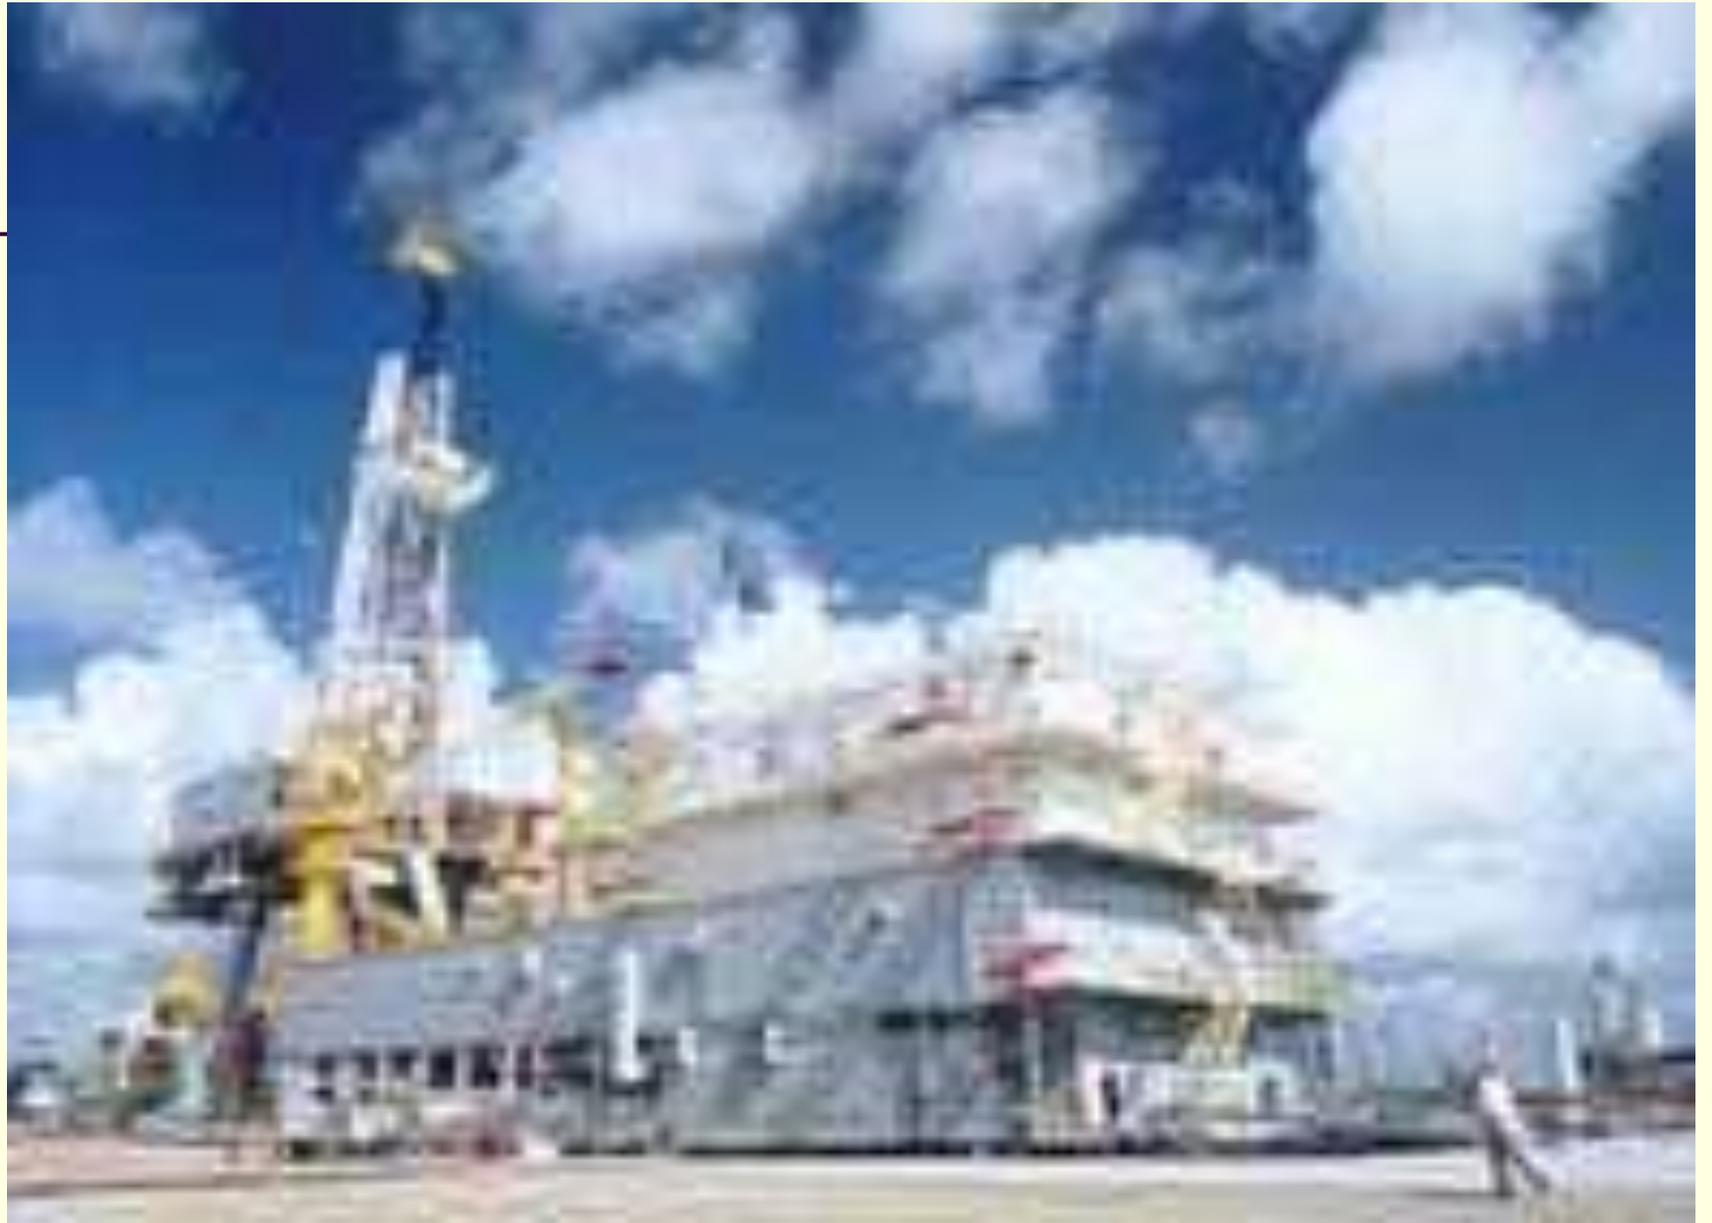
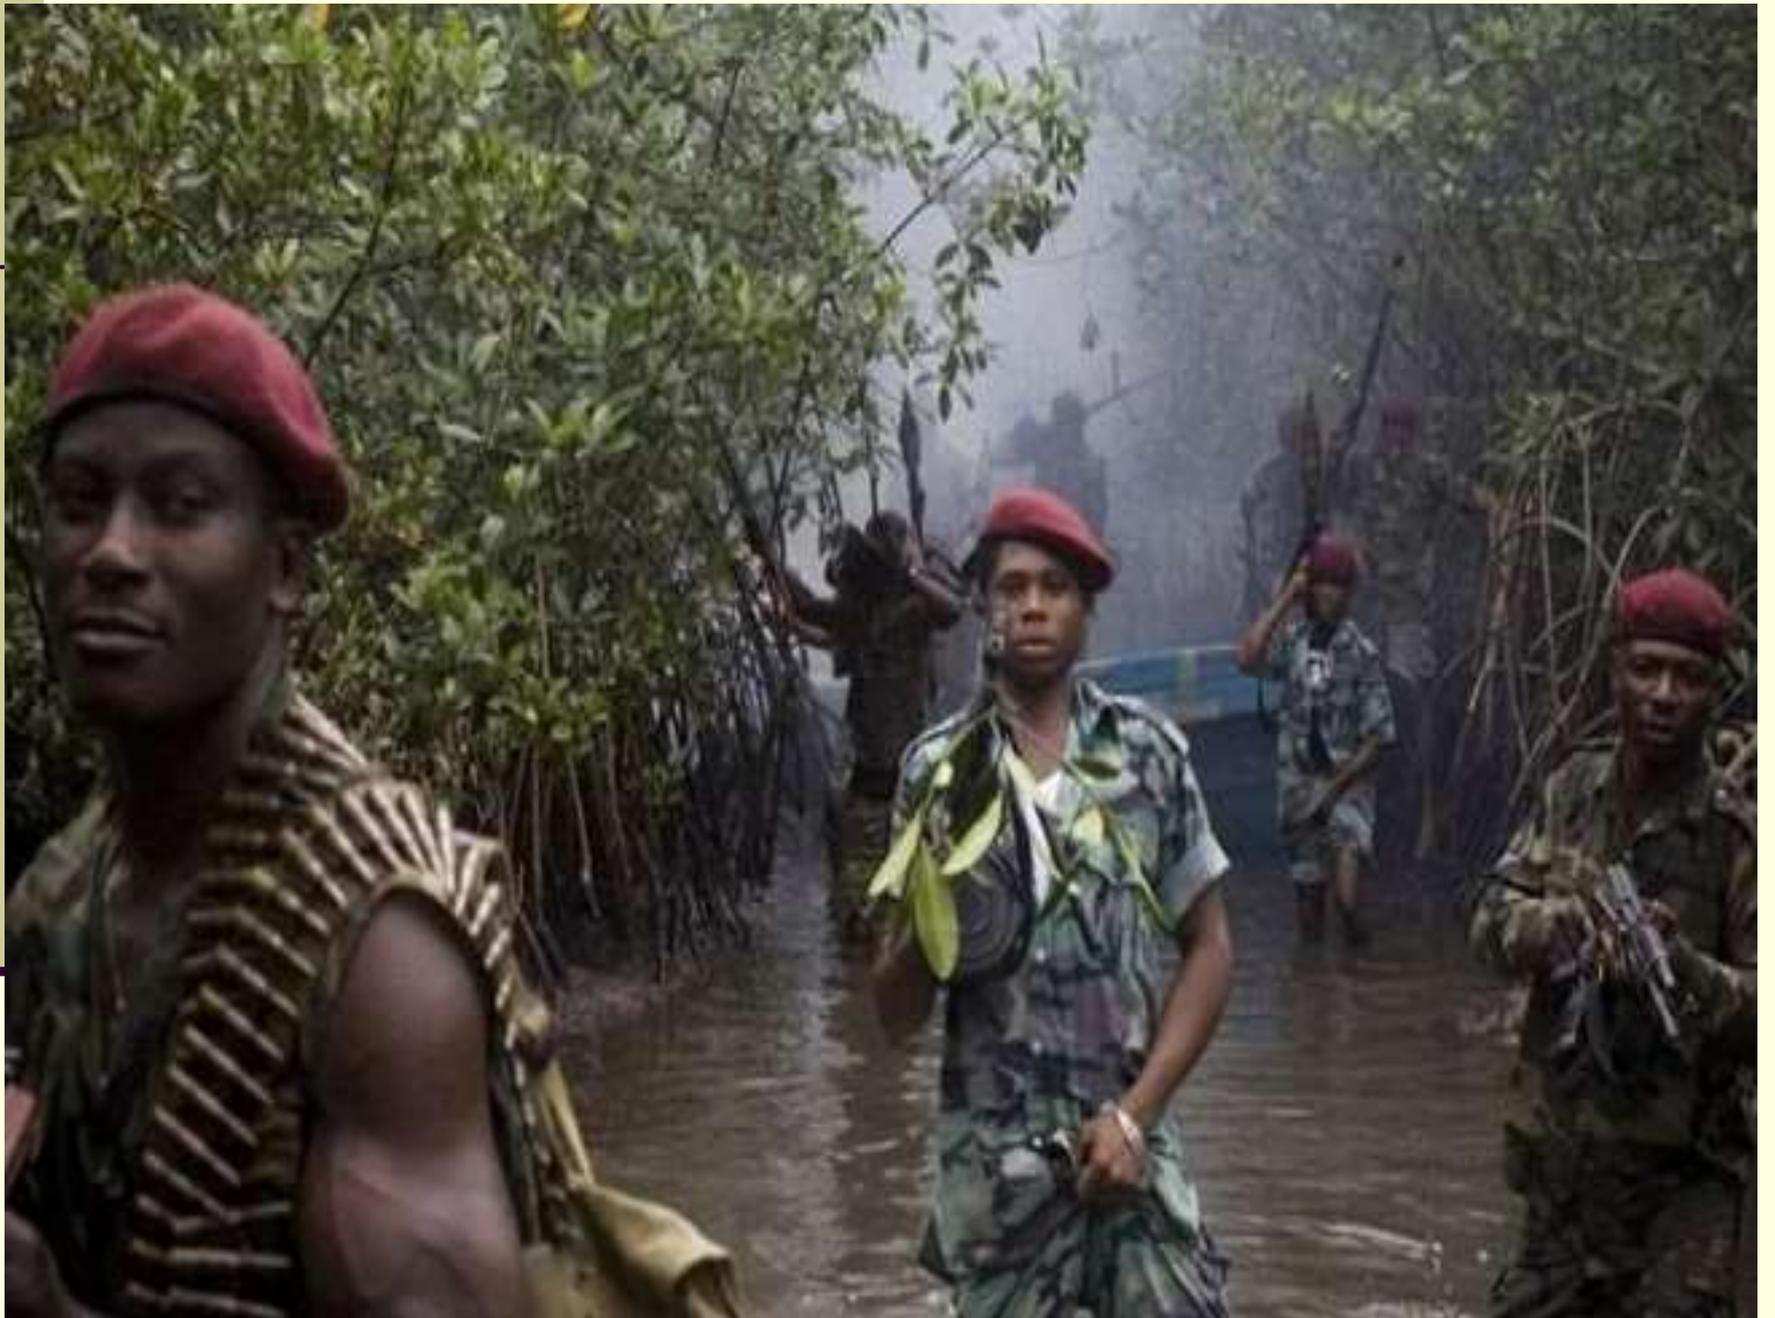
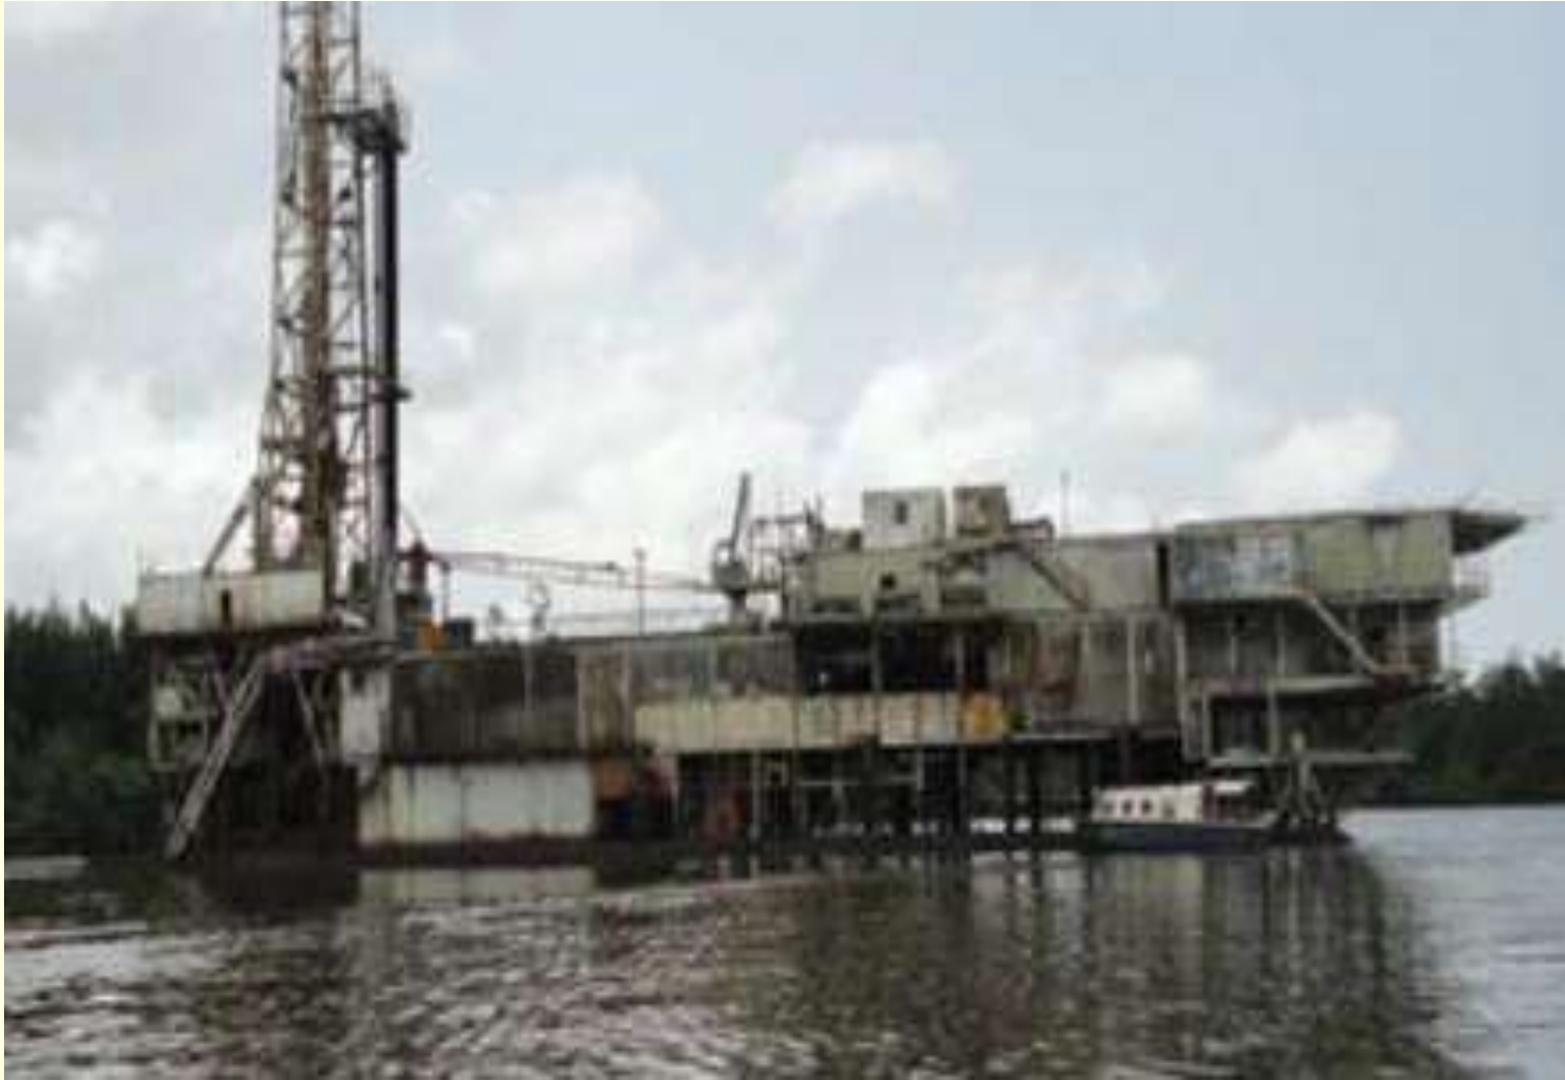
ABANDONED PARKER 74 DRILLING RIG

- In March 2003, the Parker-74 barge, an onshore drilling rig was overrun and abandoned, due to the ethnic crisis that erupted in the region
- Then it was drilling an oil well in the Remote Manifold Platform close to Benin River in Dibi area, Niger-Delta.
- After abandonment, the rig was subjected to years of vandalism, looting, corrosion and general neglect.

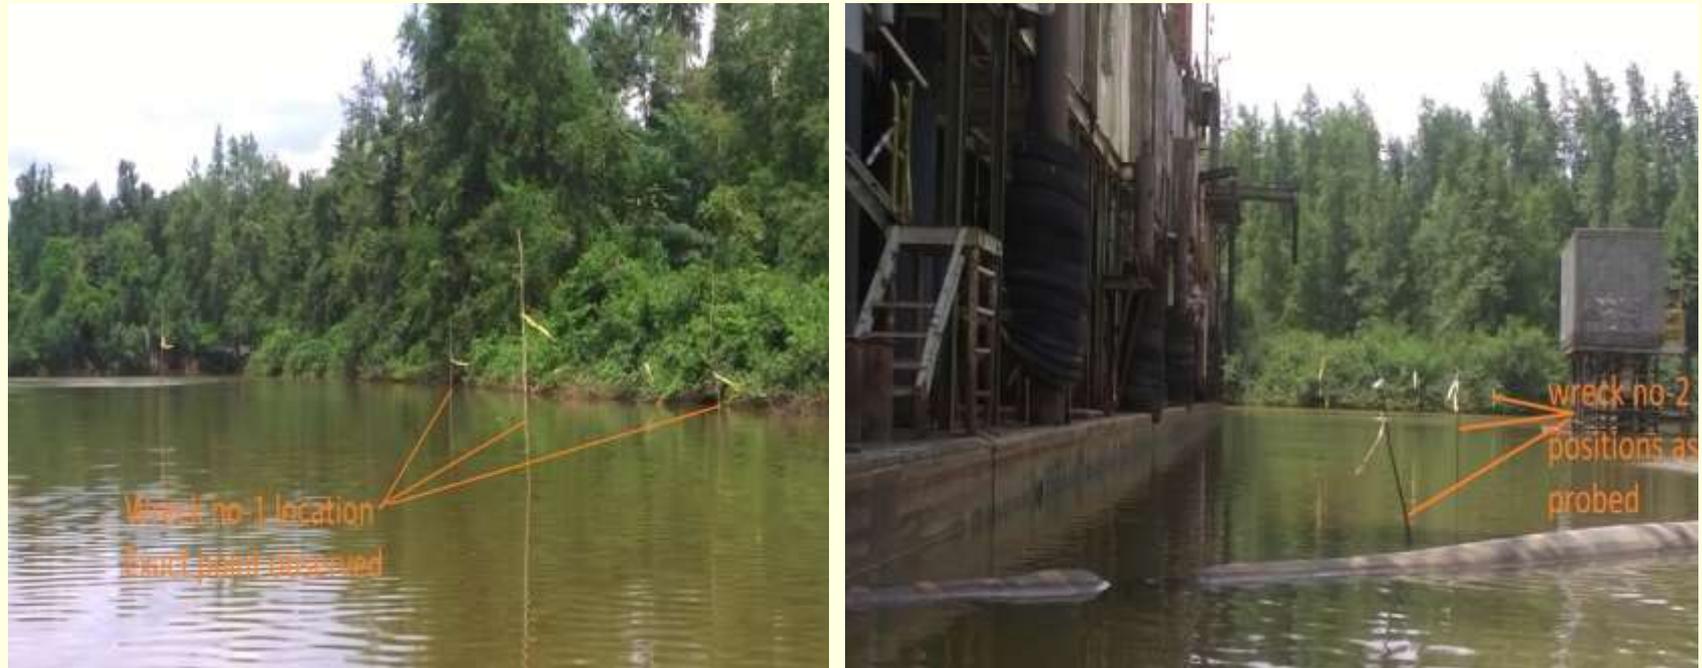
Pre-dredge Survey: wrecks/sunken items positions

Positions of wrecks / sunken items as probed during Pre-dredge Survey.

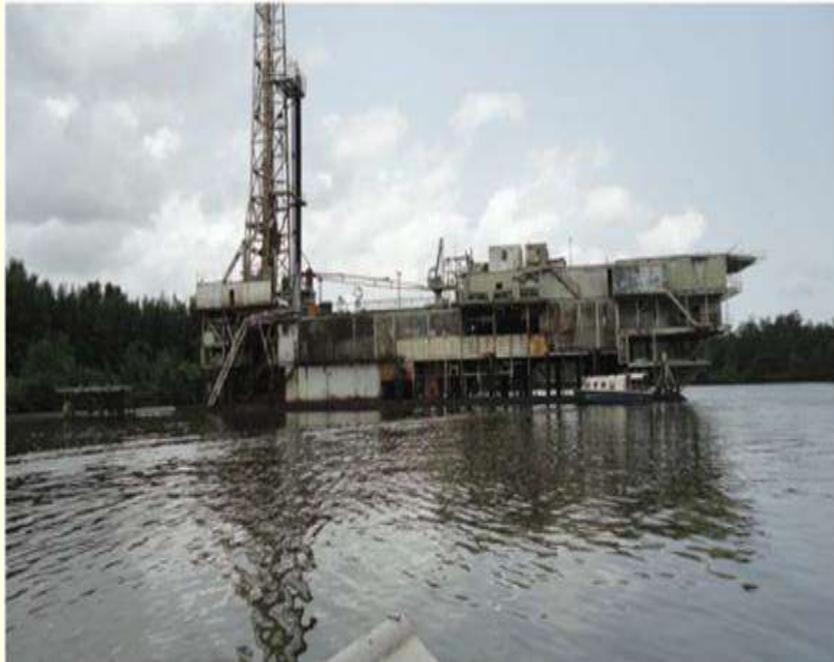
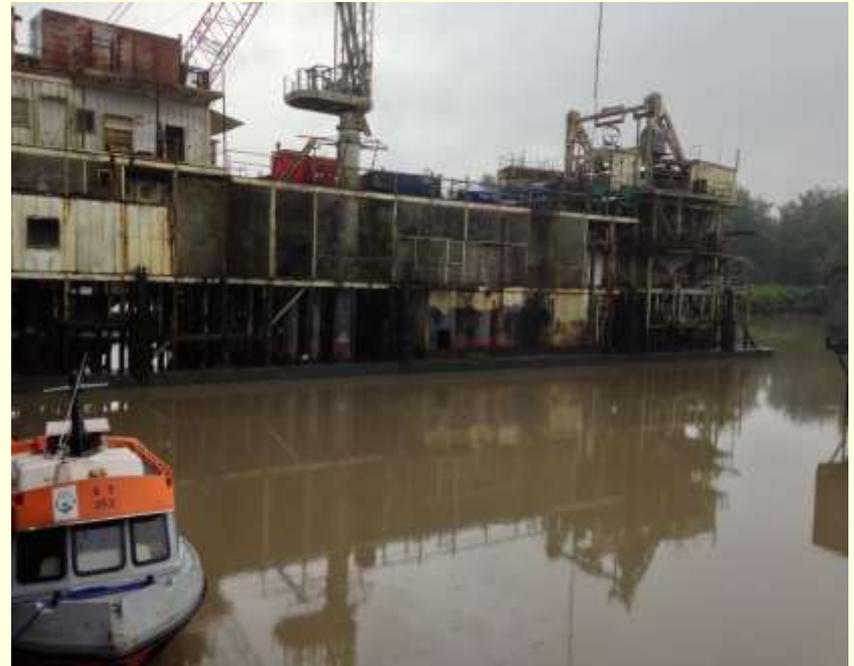
Parker-74 Rig prior to commencement of decommissioning works.

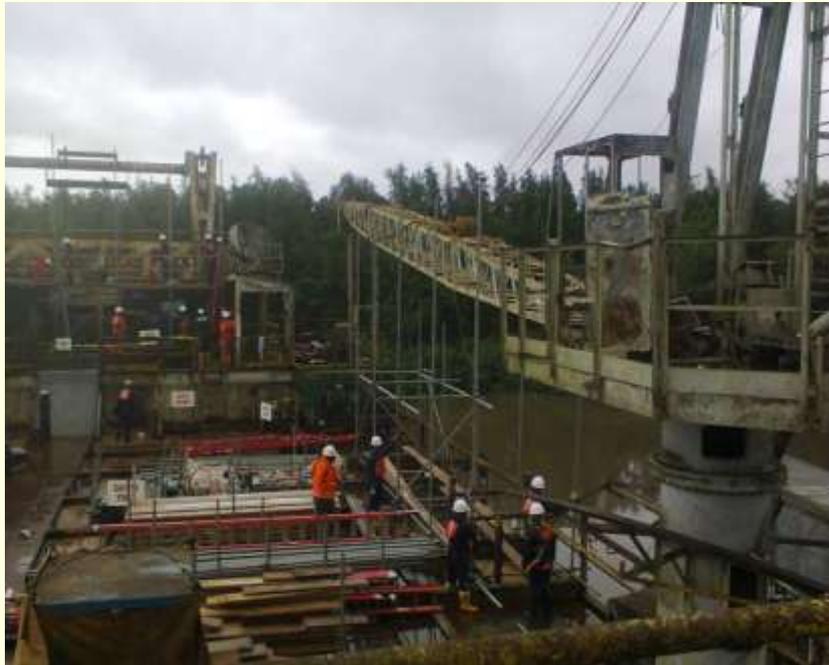
Erection of scaffold on rig floor section.

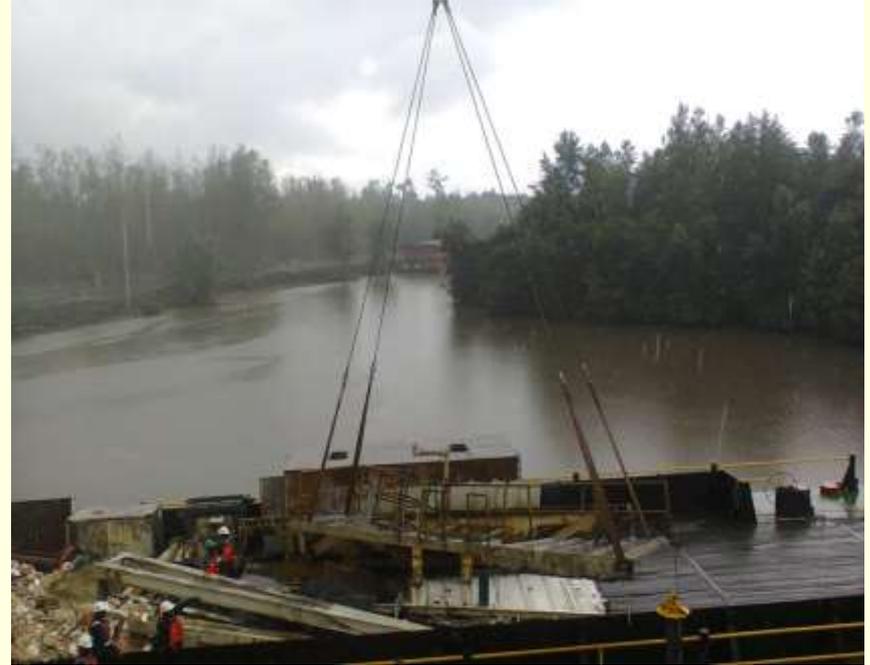
Loading of scrap materials onto the barge.

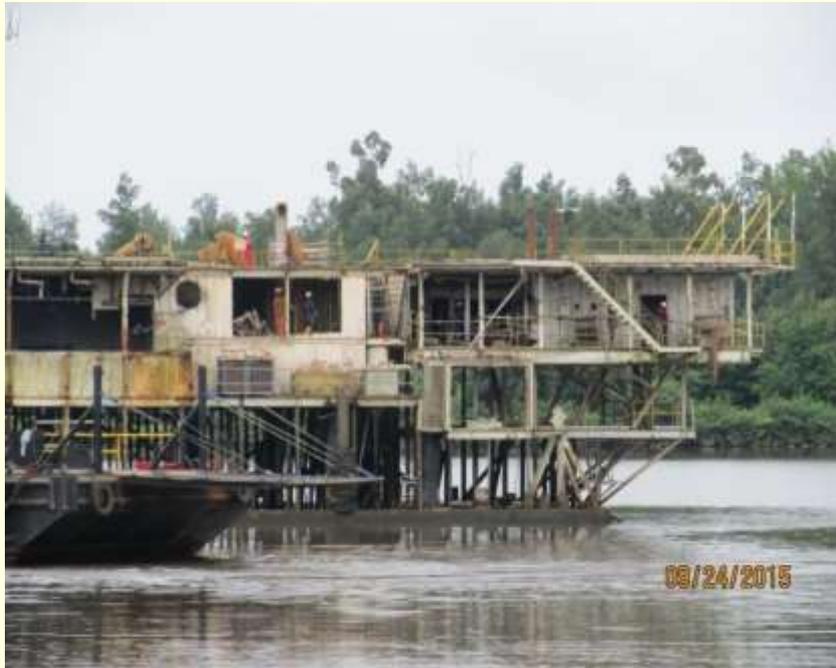
Side view of equipment section and living quarters.

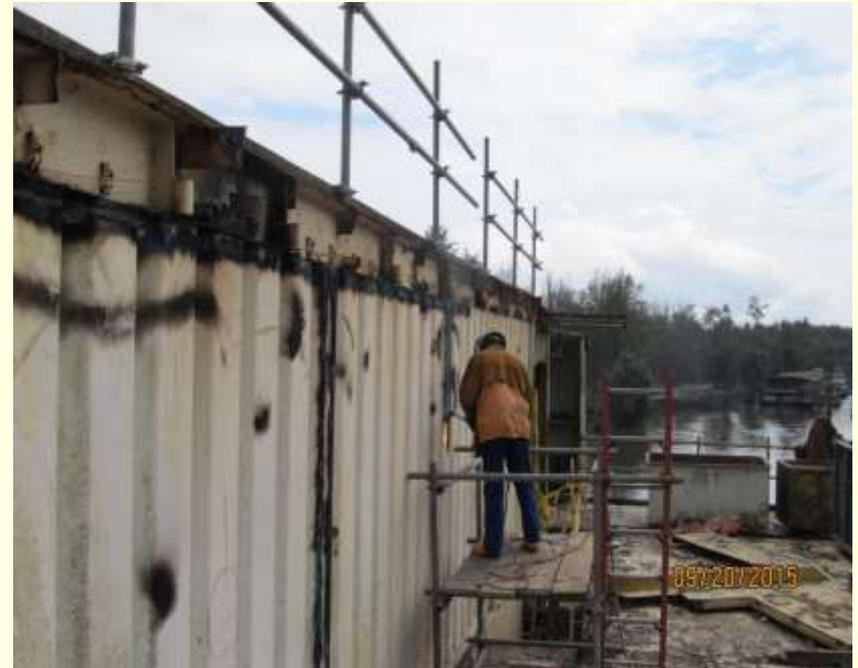
Cutting of outer accommodation wall.
