From Crisis to Reconstruction: Integrating Geospatial Technologies for Climate-Resilient Infrastructure

by Paa Kwesi Ezanator Akuffo Owusu-Ensaw
Multigeomatics Ltd

The Bridge Collapse Incident

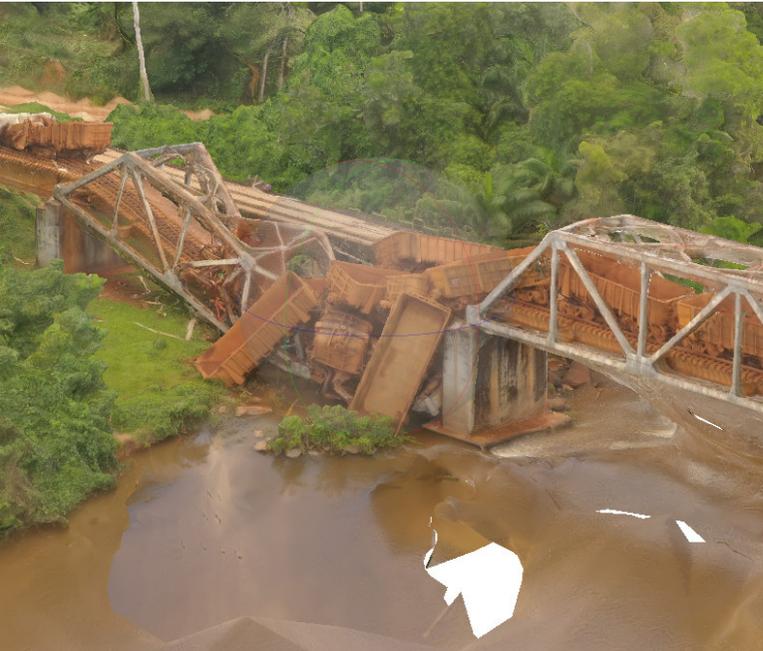
Survey Findings

LIDAR revealed lateral displacement of bridge piers by up to 12 cm and truss shifts of 8-10 cm.

Average depth of 4.2m with 2.1m of sediment accumulation increasing flood vulnerability.

Models predicted 40% increase in flow velocity during rainy seasons, threatening stability.

Monitoring pins detected ongoing settlement of 2mm per month post-impact.

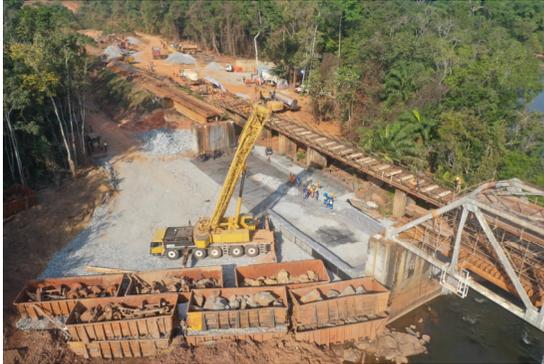
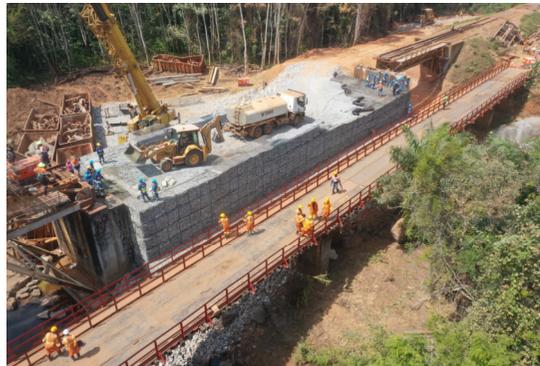
Engineering Solutions

Hydraulic jacks repositioned displaced trusses within $\pm 5\text{mm}$ tolerance.

6-meter high wall with gabion baskets protected against future flooding.

Precise elevation corrections of $\pm 4\text{cm}$ restored operational functionality.

Vegetative buffer zones reduced erosion and managed sediment accumulation.

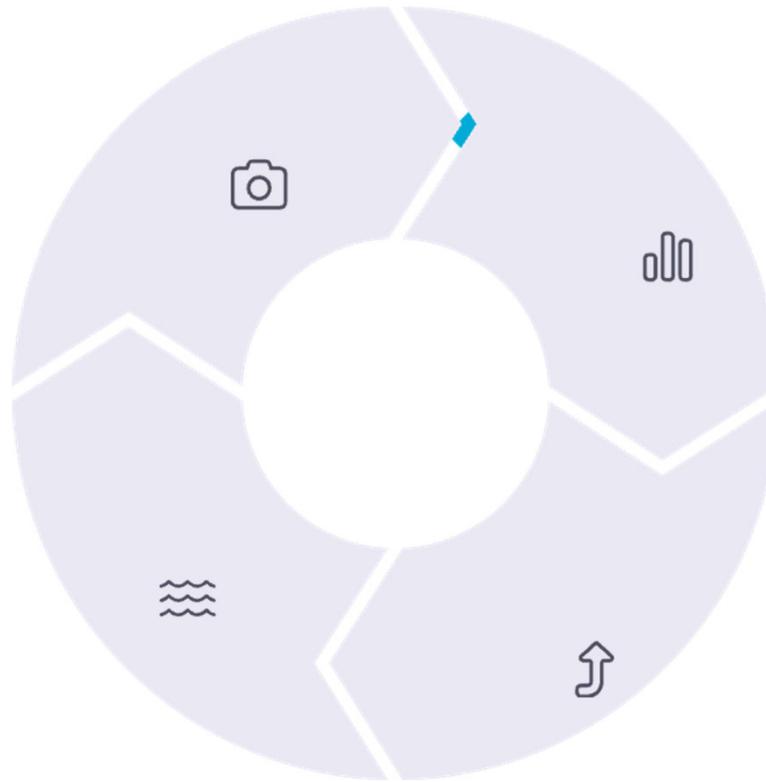
Documented construction progress and created time-lapse imagery.

Verified riverbed stability and effectiveness of erosion controls.

Monitoring pins tracked structural movement throughout and after reconstruction.

Regular measurements ensured bridge stability within tolerances.
